INDOOR AIR QUALITY ASSESSMENT

**Country School
Alphabet Lane
Weston, Massachusetts**

Prepared by:
Massachusetts Department of Public Health
Bureau of Environmental Health Assessment
Emergency Response/Indoor Air Quality Program
July 2003

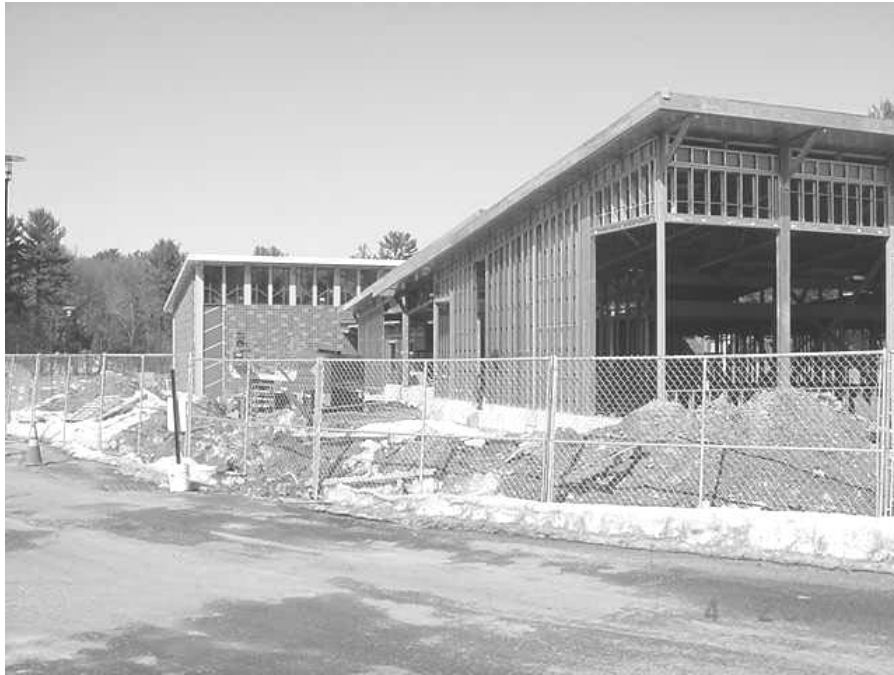
Picture 1

On March 4, 2003, a visit was made to this school by Cory Holmes, an Environmental Analyst in BEHA's Emergency Response/Indoor Air Quality (ER/IAQ) program, to conduct an assessment. Mr. Holmes was accompanied by Ms. Diotalevi. The building consists of two wings. The original building was constructed during the 1960s as a single story red brick structure. The original wing was recently renovated and a new wing was under construction at the time of the assessment (see Picture 1). Windows are openable throughout the building.

Country Elementary School With New Addition in Foreground

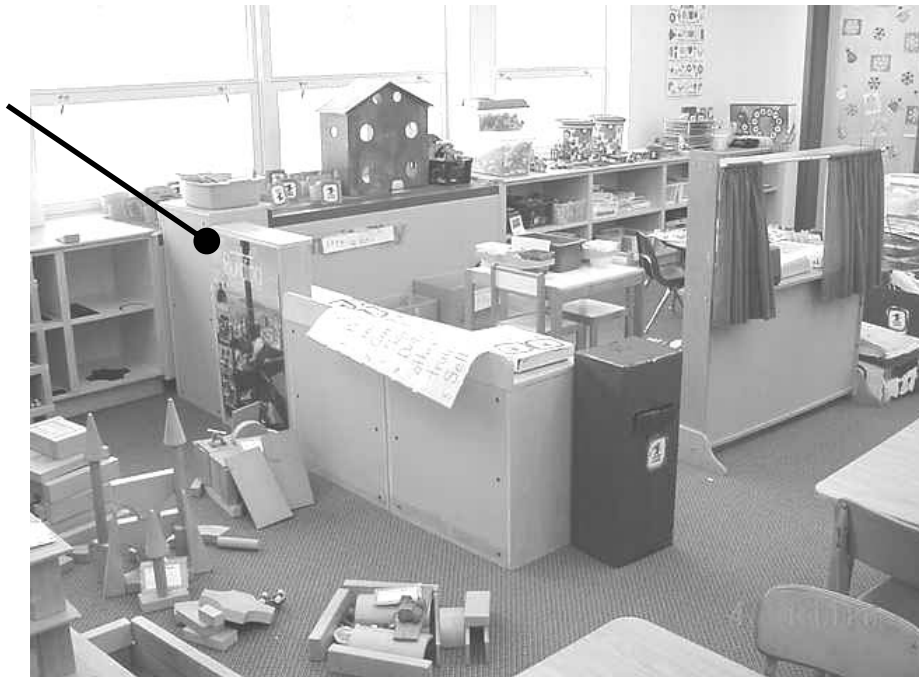
Picture 2

Fresh air in classrooms is supplied by a unit ventilator (univent) system or rooftop air handling units (AHUs). Univents draw air from outdoors through a fresh air intake located on the exterior walls of the building and return air through an air intake located at the base of each unit. The mixture of fresh and return air is drawn through a filter and a heating/cooling coil, and is then provided to classrooms by motorized fans through fresh air diffusers located at the top of the unit (see Figure 1). AHUs draw air from outdoors through a fresh air intake and distribute it to occupied areas via ceiling-mounted diffusers connected to ductwork. Univents and AHUs were functioning in all areas examined. Univents and some air diffusers were found obstructed by various items in several classrooms (see Tables/Pictures 2-4). In order for univents to function as designed, the fresh air diffuser and return vents must be clear of obstacles.

Classroom Univent Surrounded By Furniture Obstructing Airflow

3. Remove all obstructions from univent air diffusers and return vents to facilitate airflow.
4. Faculty and staff are encouraged to report any complaints concerning temperature control/preventive maintenance issues to the facilities department via the main office.

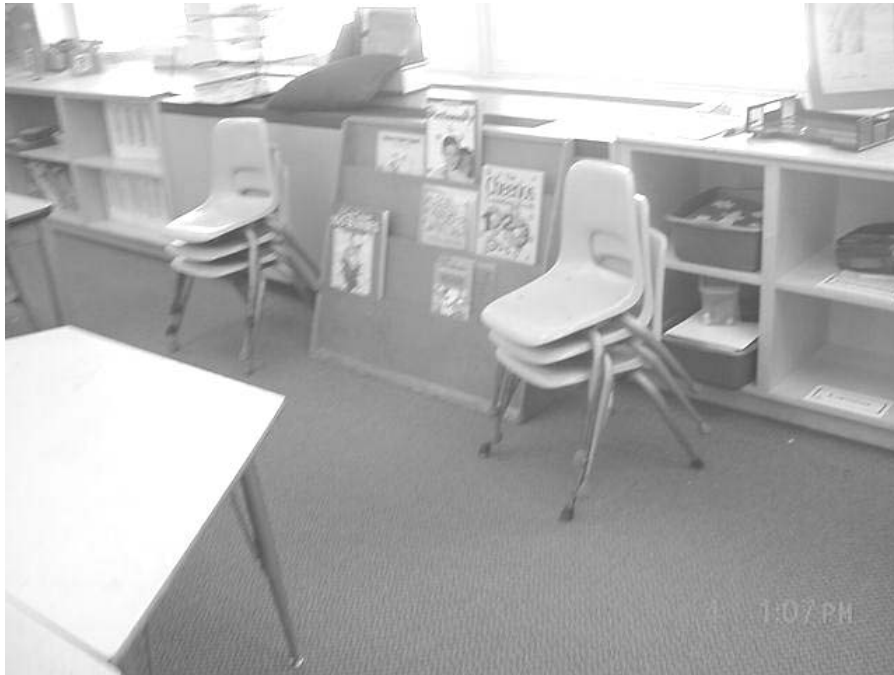
Picture 3

Items Obstructing Univent Return Vent

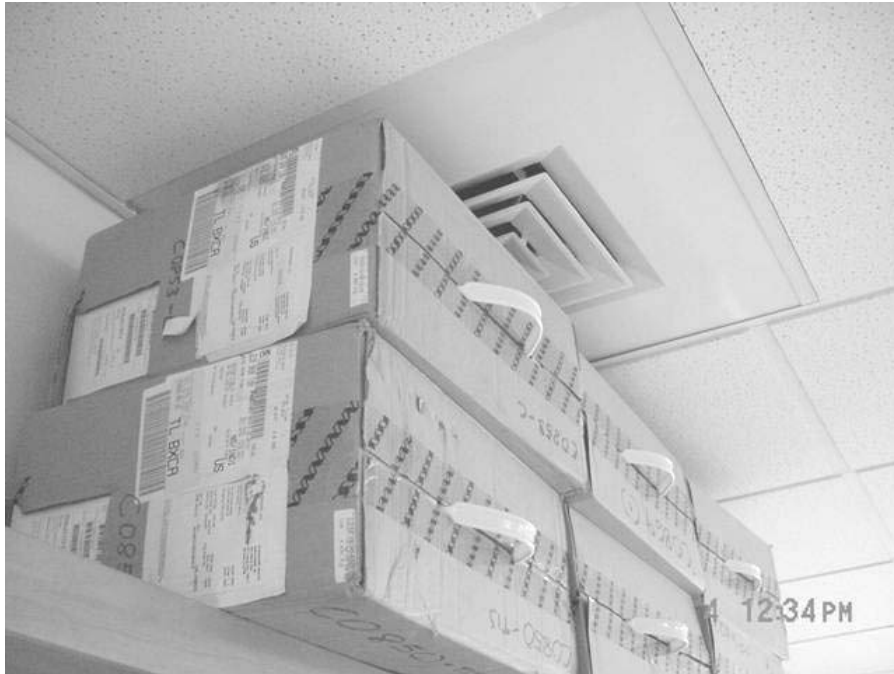
Picture 4

Ceiling-Mounted Air Diffuser Obstructed by Boxes Stored on Cabinet

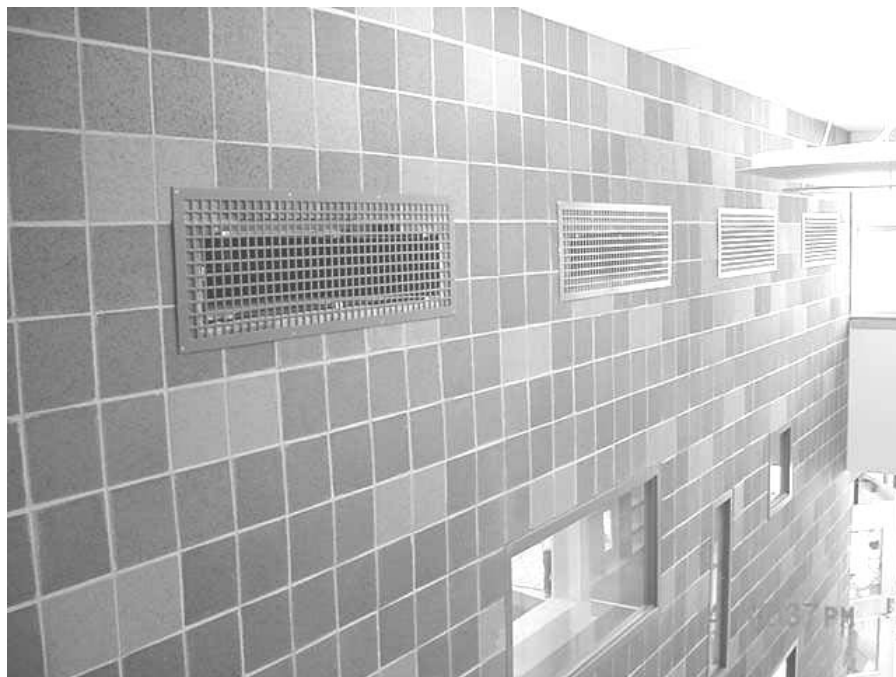
Picture 5

Temperature measurements ranged from 68° F to 78° F, which were close to the BEHA recommended comfort range. The BEHA recommends that indoor air temperatures be maintained in a range of 70° F to 78° F in order to provide for the comfort of building occupants. In many cases concerning indoor air quality, fluctuations of temperature in occupied spaces are typically experienced, even in a building with an adequate fresh air supply. Heat complaints were reported on the second floor near the school nurse's suite. The school nurses' suite is located directly across from a series of heating vents in the upper wall of the lobby (see Picture 5). These vents appeared incomplete due to the lack of louvered grates on the terminus of the ductwork. Without louvered vents to direct air downward (to warm incoming occupants) the ducts force hot air straight across the lobby toward the second floor nurses' suite.

Lobby Heating Vents across from Nurse's Suite, Note Lack of Louvered Grates for Directional Airflow

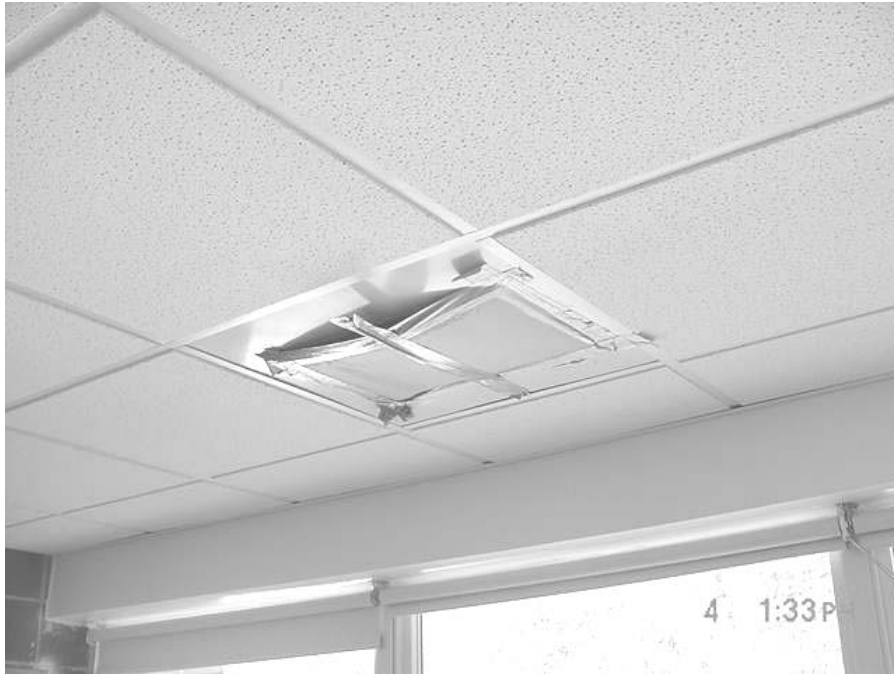
Picture 6

Heat complaints were also expressed in room C-112. In an effort to reduce heat, the supply vent in C-112 was blocked with masking tape and cardboard (see Picture 6). This alteration of the system, however, can throw the system off-balance and create uneven temperature conditions in areas adjacent to the blocked diffuser.

Blocked Vent in Room C-112

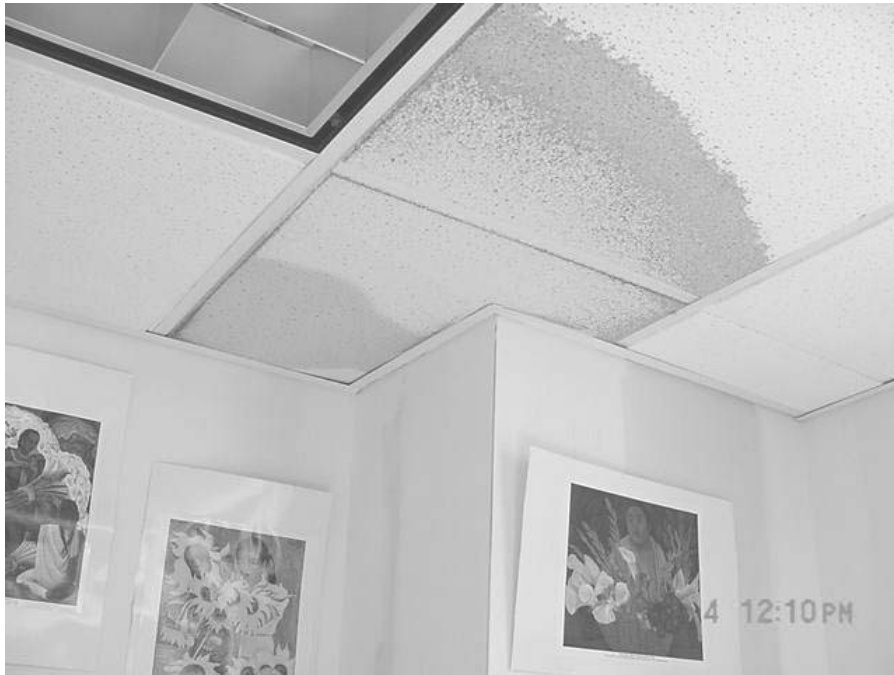
Picture 7

Water damaged ceiling tiles were observed in room 202 (see Pictures 7). Occupants reported an active roof leak in this area. Water-damaged ceiling tiles and porous building materials can provide a source of microbial growth and should be replaced after a water leak is discovered.

Water Damaged Ceiling Tiles in Room 202
